Directionally Drilled Bores For Remote Cable Landings

Abstract - A cable shore landing protection system was needed at Southwest Bay, Ascension Island, to protect future cables coming ashore. Three subsurface conduits were installed from the shore out under the seafloor, using a lightweight horizontal drill rig. These three Directionally Drilled Boreholes range from 500 to 800 feet in length, and exit the seafloor at water depths of 35 feet or greater. These boreholes were installed in late August and early September of 2002. This effort took 13 days on site to accomplish.

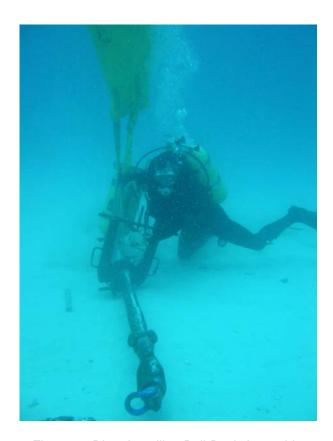
Figure 6. Diver Removing Drill Head.

A liner (conduit) is required in boreholes to ensure that the holes stay open for cable coming ashore. Installation of the conduit in the boreholes was accomplished by pulling HDPE pipe back through each borehole upon the completion of drilling. The process involved divers first locating the drill pipe exiting the seafloor. The divers remove the drill head assembly with specialized tools, as shown in Figure 6. The divers then attach a pull back swivel to the drill pipe, as shown in Figure 7.
